DRAINAGE REPORT

John A Herbert

This report is based on the visual inspection of several sample apartments within the Lung Hang Public Housing Estate, Shatin, Hong Kong. The inspection, arranged and coordinated by the office of Legislative Councillor Emily Lau, was conducted at 2.30 pm on 2nd May 2003. Members from the Housing Authority Lung Estate office led by Mr Chu, representatives from Emily Lau's office, Mr Wilson Chu Esq. District Councillor, Shatin District Council and Mr John A. Herbert, Kelcroft Consulting Engineers attended.

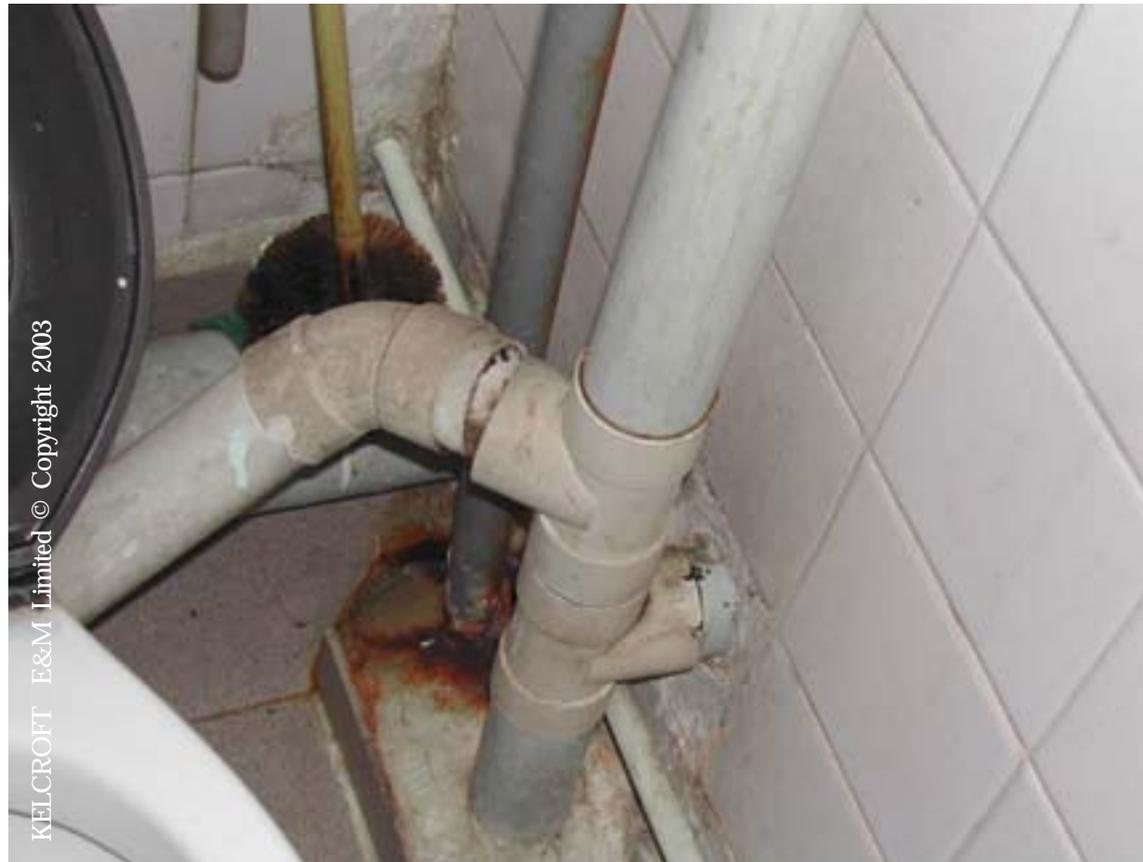
Drainage Installation - Photograph 1

High SARS Risk 1

- WC Anti-Syphonage pipe failed
- High SARS Risk
- Poor jointing workmanship
- Missing pipe brackets

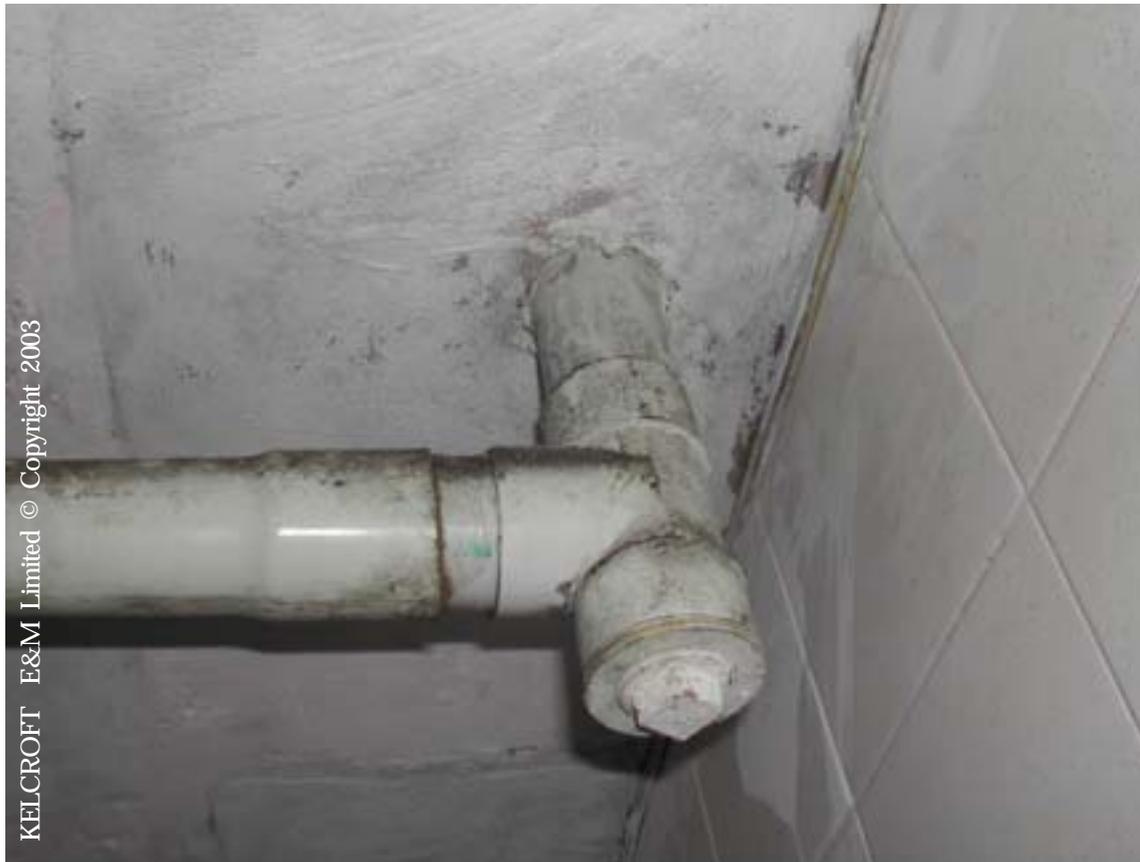
Drainage Installation - Photograph 2

High SARS Risk 2

- High SARS Risk
- Leaking Pipework
- Water Damage / future spalling
- Missing pipe bracket

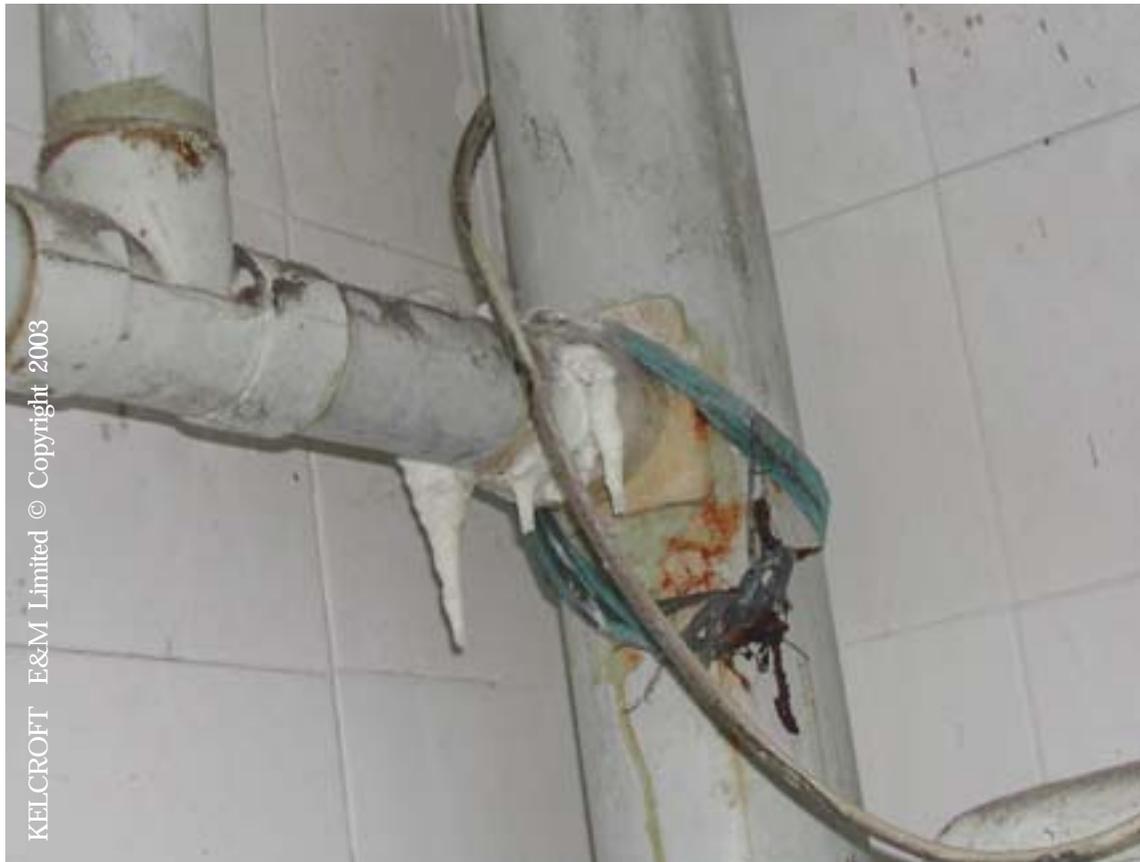
Drainage Installation - Photograph 3

High SARS Risk 3

- High SARS risk
- Waste Pipe leakage
- Missing brackets

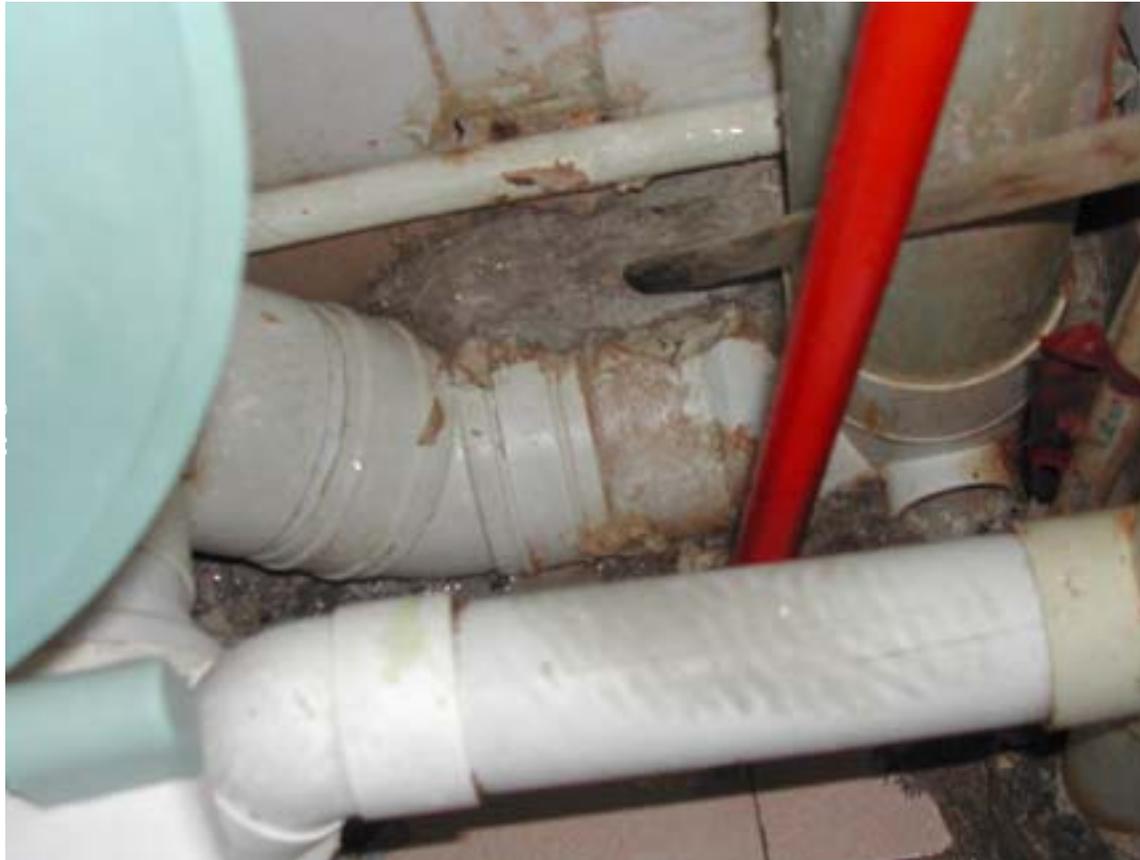
Drainage Installation - Photograph 4

Soil Pipe Leakage 1

- Soil Pipe Leakage
- SARS risk
- Inadequate repair attempted

Note: Anti-syphonage piping (white colour pipe in foreground) used as step

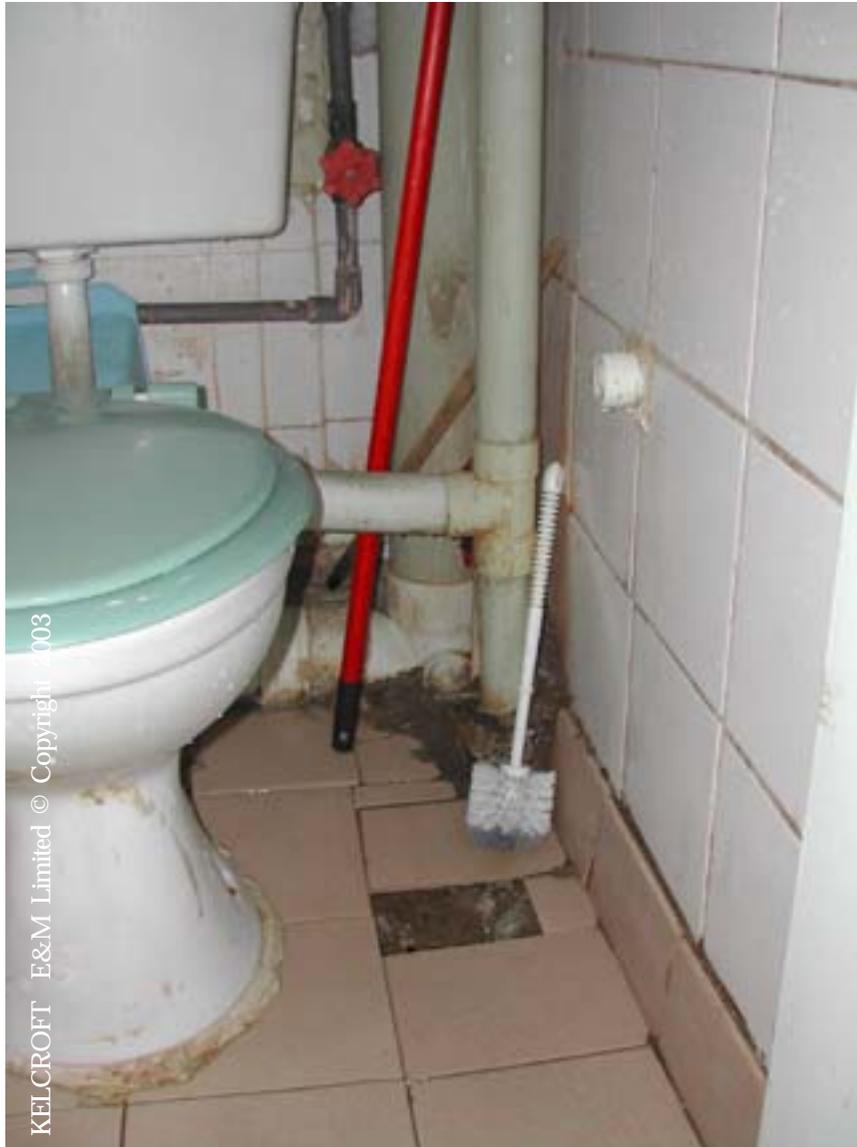
Drainage Installation - Photograph 5

Soil Pipe Leakage 2

[as photo 4 different angle]

- 108mm uPVC soil and waste stack pipe fitting partially embedded within slab
- Anti-syphonage pipe below flood level, wrong gradient
- Missing pipe bracket

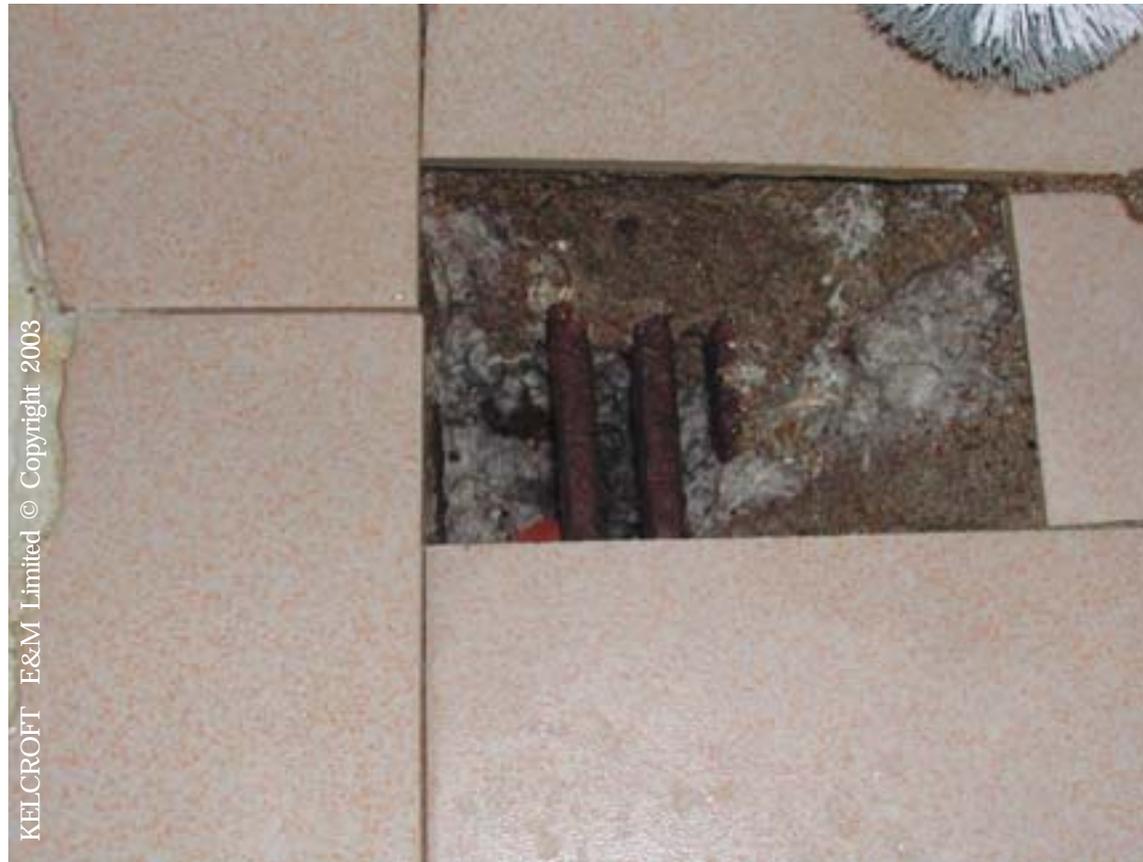
Drainage Installation - Photograph 6

A recessed style floor drain (apparently formed from the concrete slab) is provided. Internal inspection reveals exposed the concrete structure (refer to photograph). No evidence of purpose made water tight components was noted.

Typical Floor Drain

- Opening formed in concrete slab
- No water proofing visible
- No components visible

These problems could be resolved with the installation of properly installed pipe sleeves, water proofing and purpose made floor drains, preventing further leakage, hence reducing maintenance. It should be noted that the cost and disturbance to tenant’s during remedial work would be significant.

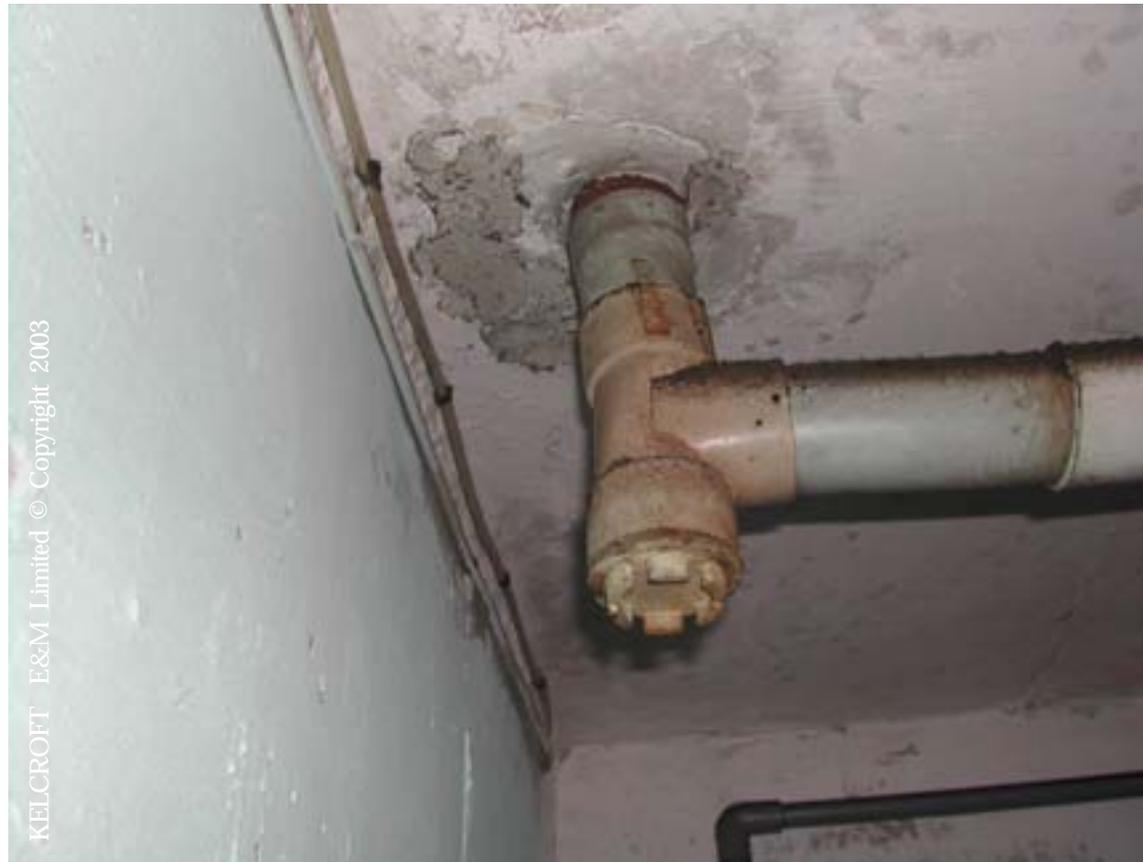
Drainage Installation - Photograph 7

Floor Drain Leakage 1

- Pipework Misalignment
- Water damage / future spalling
- Water leakage from above
- Missing pipe bracket

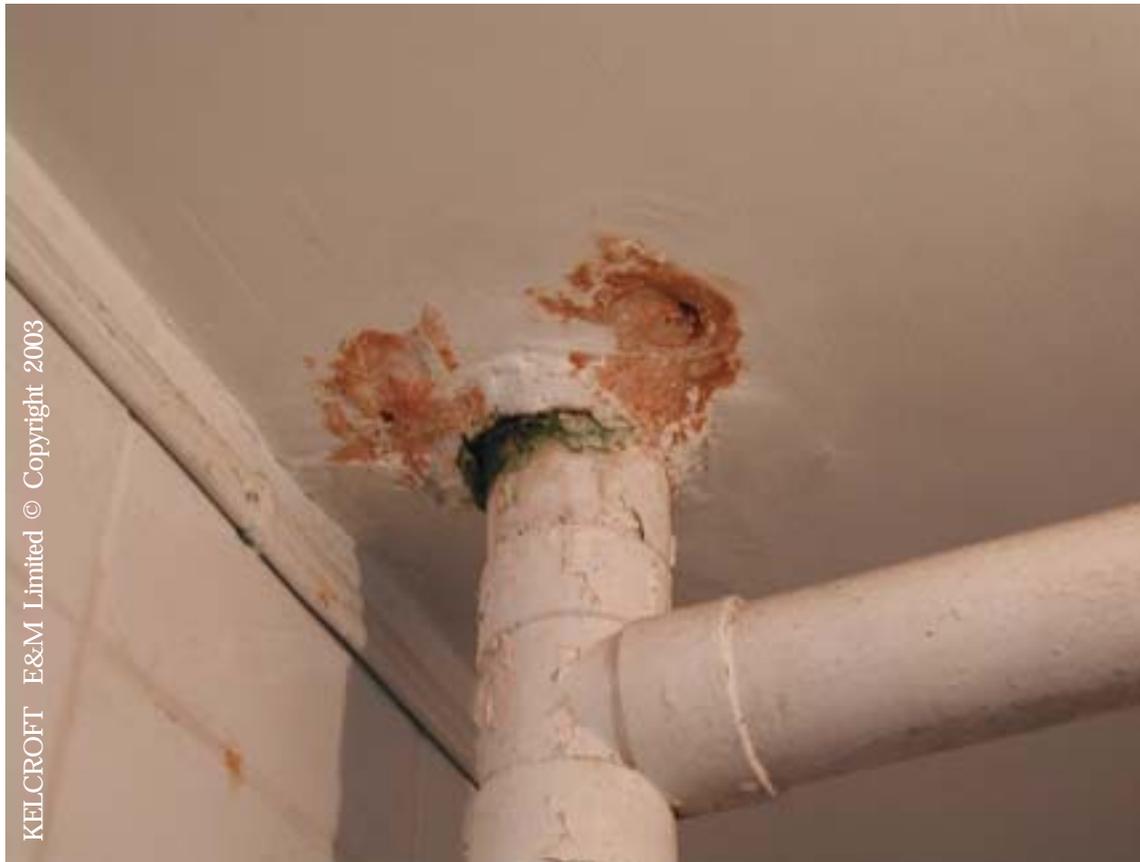
Drainage Installation - Photograph 8

Floor Drain Leakage 2

- Water leakage from floor drain arrangement in bathroom above causing concrete deteriorating and spalling
- Missing pipe brackets

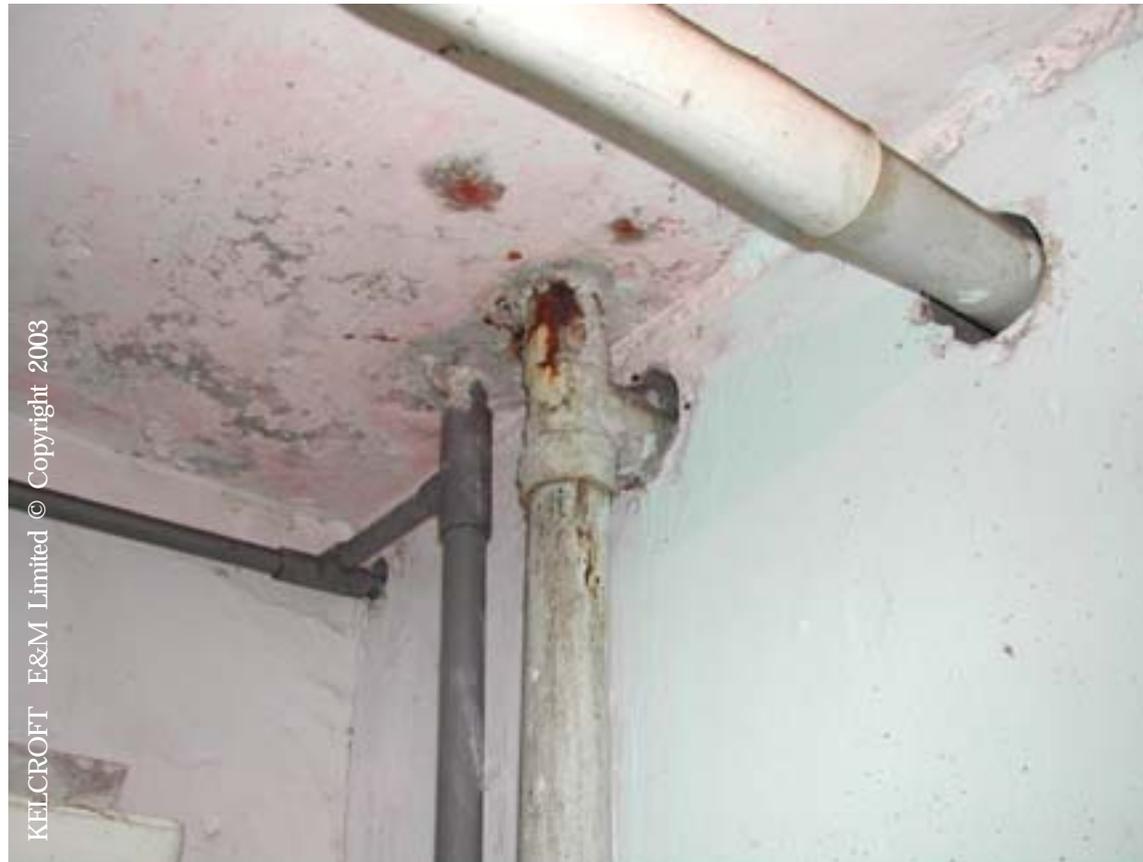
Drainage Installation - Photograph 9

10. Contravention of regulation⁸, clause 36 and Code of Practice for Fire resisting Structure. Drainage pipework passing through fire compartment partitions shall be sealed.

Fire Compartmentation

- Inadequate Fire Stop
- Pipe failing (centre top)
- Ceiling water damaged
- Missing pipe brackets

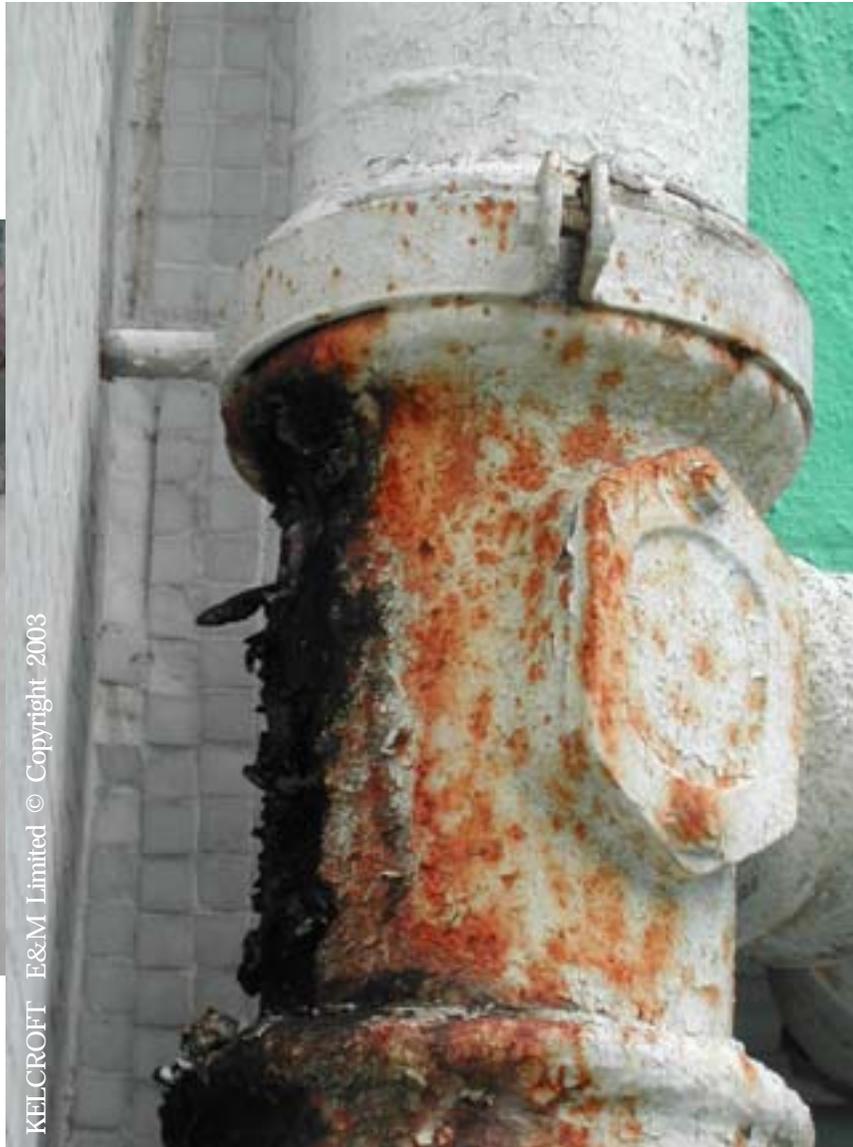
Drainage Installation - Photograph 10

It was noted that the storm water system employed for "Double H" buildings comprise externally mounted 150 mm (6 inch) cast iron storm water downpipes. These are routed from roof level to ground level, with branch pipes from each floor are connected to downpipe. It is obvious that the storm water system was neglected, particularly the complete failure of a 150 mm (6 inch) cast iron pipe fitting (refer to photographs).

9. Contravention of regulation⁸, clause 36. External 150 mm (6 inch) Cast Iron Storm water pipework fitting Lok Sam House at level 24, has failed (refer photo xxx).

Storm Water
Downpipe

Storm Drainage

- H block Style building
- 150mm Cast Iron downpipe
- Pipe fitting failed
- Leakage and corrosion and noted

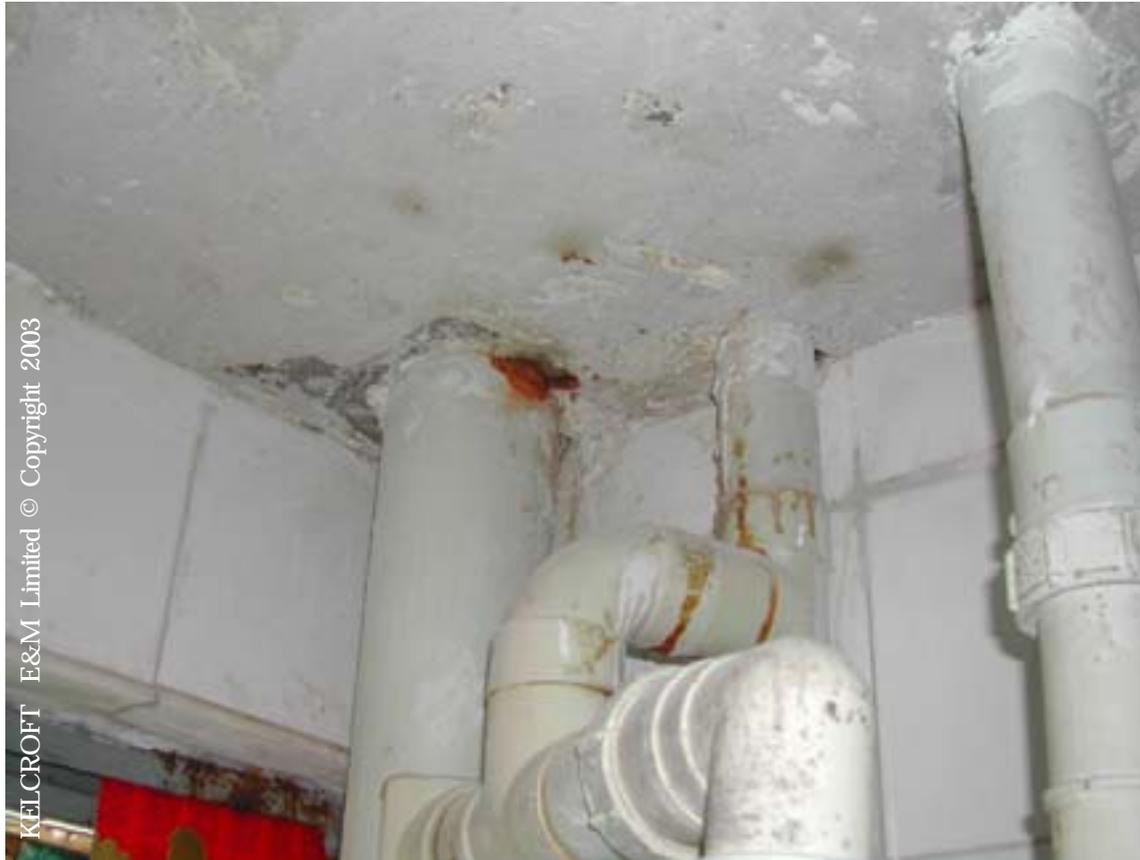
Drainage Installation - Photograph 11

Water Damage

- Bathroom ceiling water damage
- Seepage/leakage from above
- Corrosion staining from above

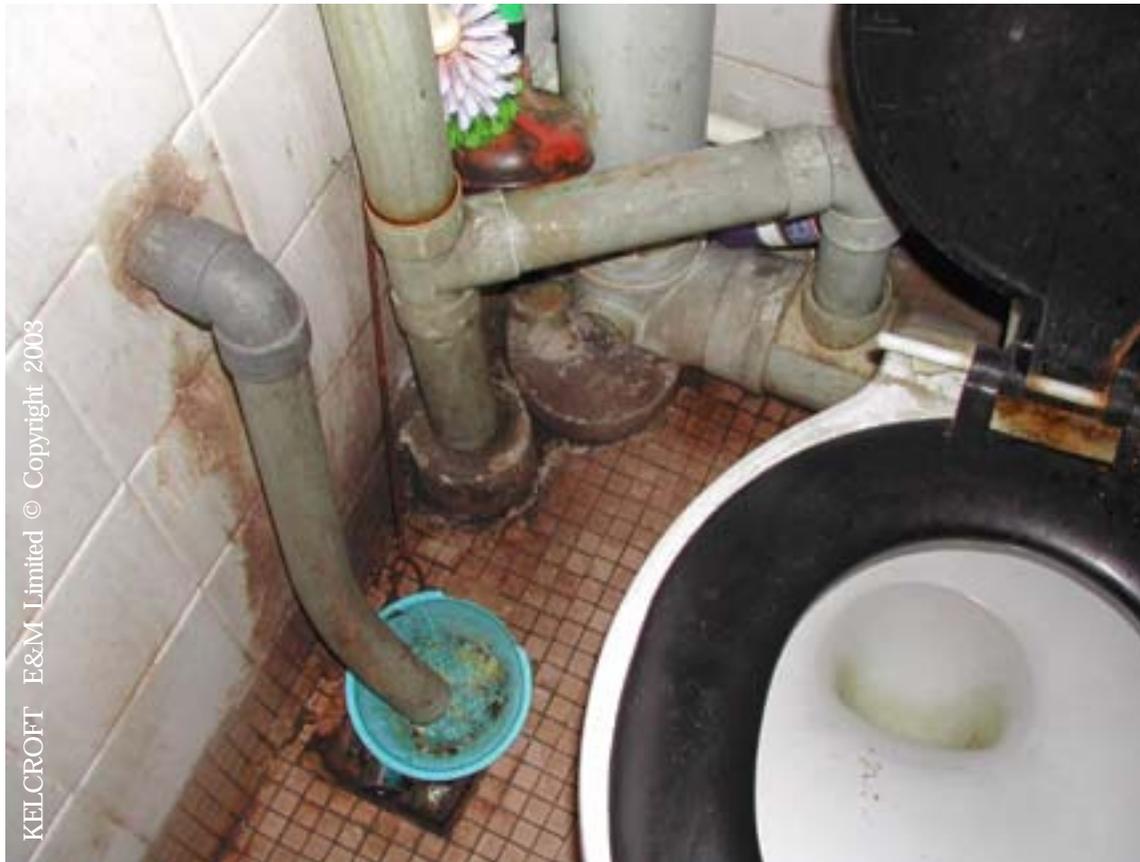
Drainage Installation - Photograph 12

11. A 108 mm (4 inch) uPVC Soil stack incorrectly installed (original installation). Pipe should be rerouted through waterproof pipe sleeve.

Pipe Sleeve

- Pipework routed outside pipe sleeve
- Anti-syphon pipe below flood level

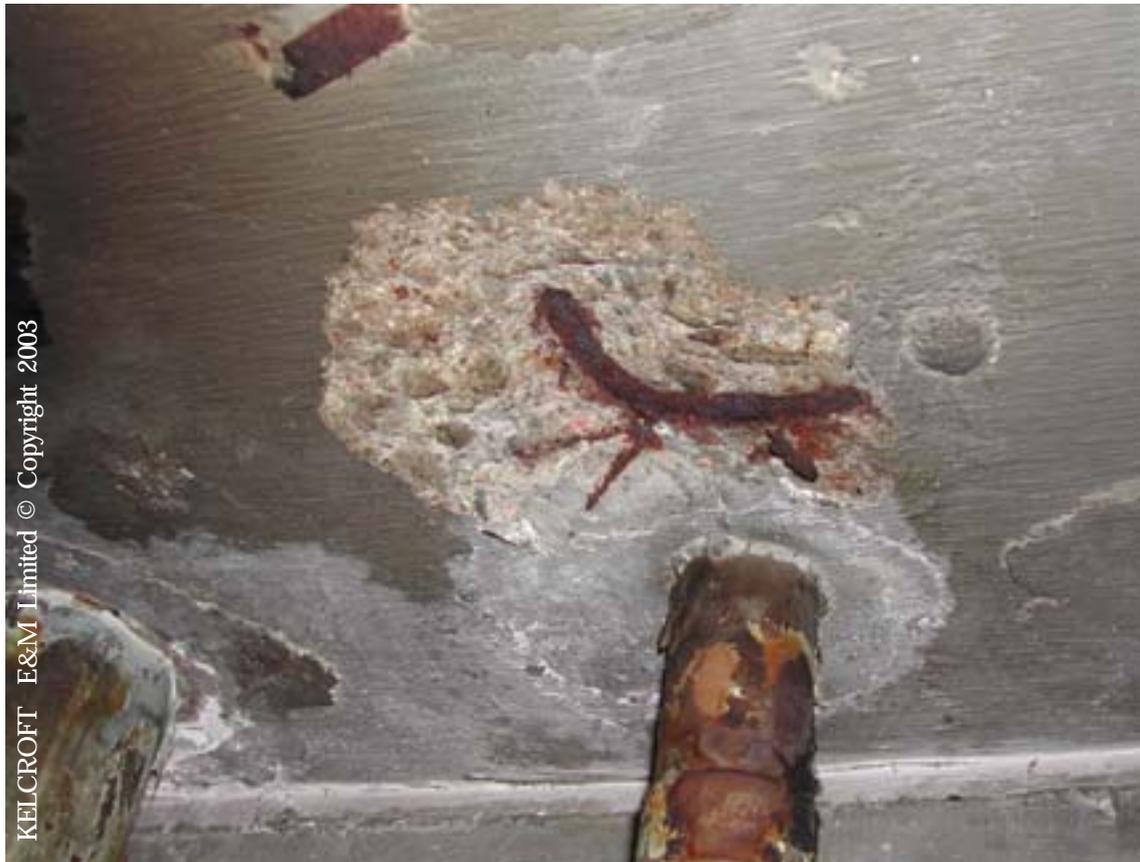
Drainage Installation - Photograph 13

Spalling 1

- Water Damage
- Spalling concrete deterioration
- Adjacent to kitchen slab waste pipe

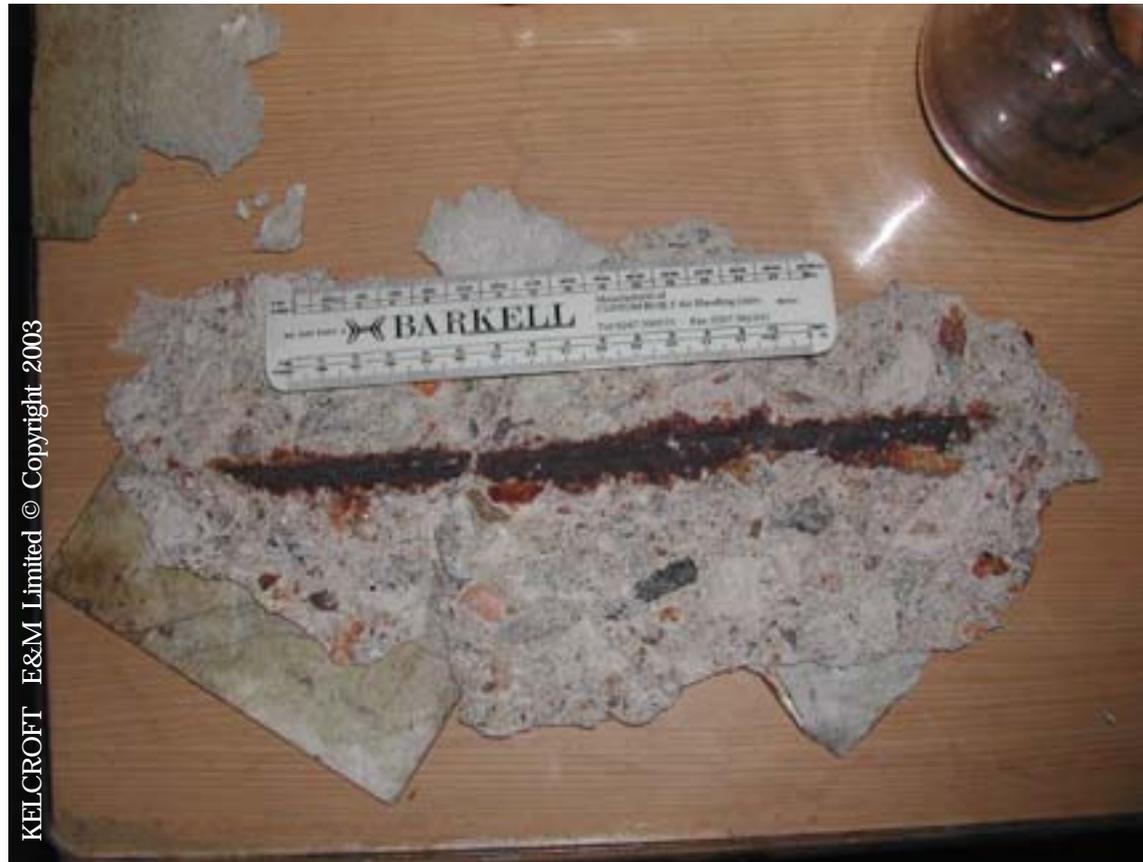
Drainage Installation - Photograph 14

Spalling 2

- Sample of fallen Concrete

Section of concrete, was stored by tenant. It measures approx. 200mm x 150mm x 10mm, with rebar corrosion clearly visible.

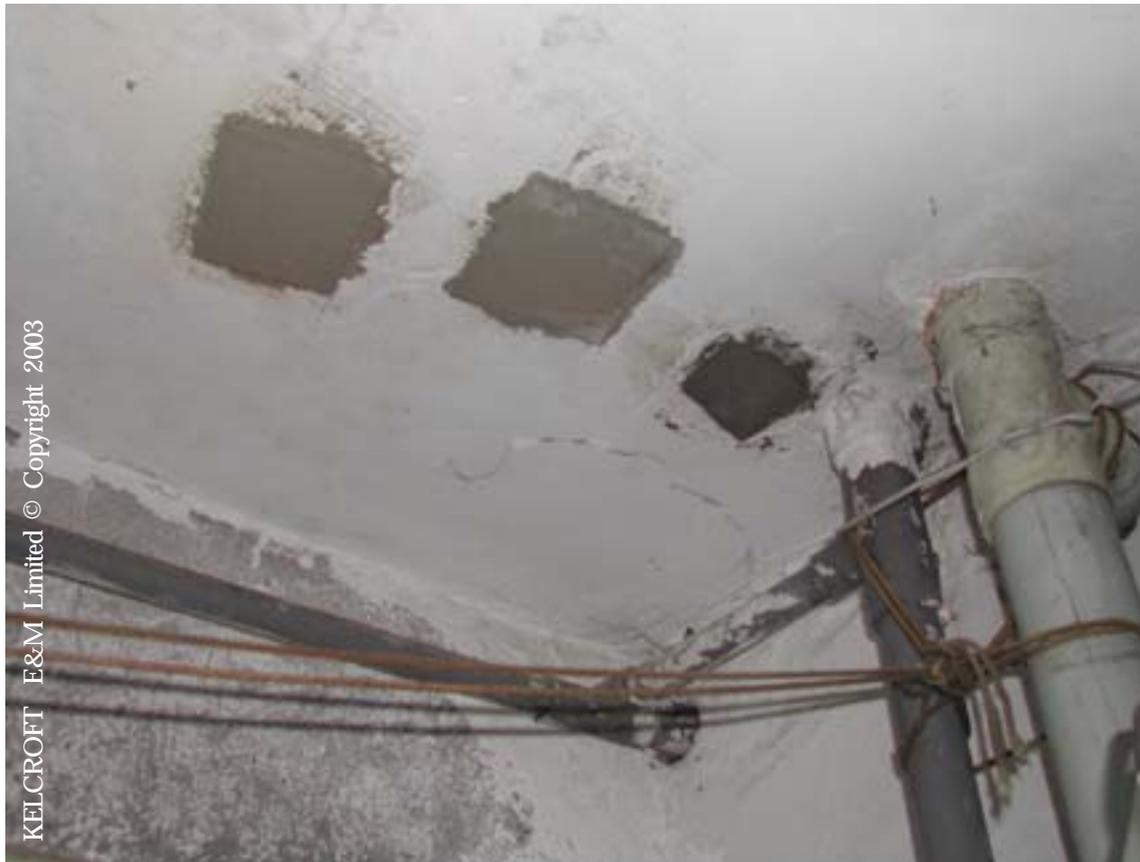
Drainage Installation - Photograph 15

Spalling 3

- Three small areas repaired
- Repaired areas not yet re-painted
- Large spall area developing in corner
