Energy Audit

Cutting Energy Costs

by John Herbert

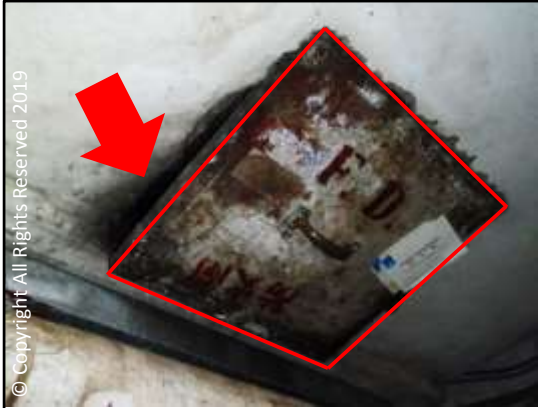
Supply air duct access panel open. Located near the AHU (highest duct pressure) huge leak into non-conditioned plant room, air flow into the building is reduced. wasting energy.

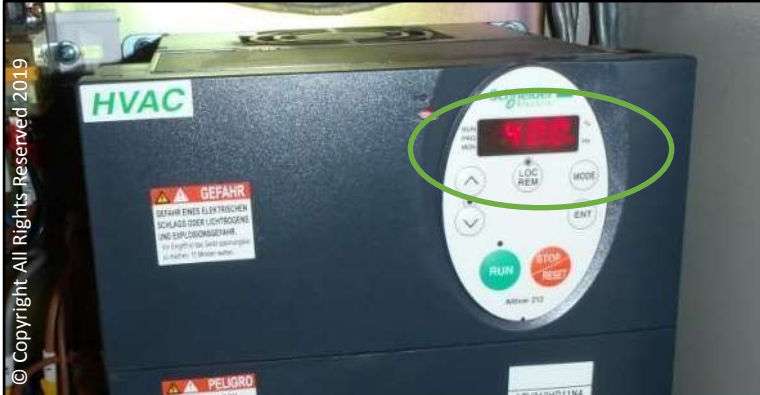
Demand Controlled Ventilation Air Conditioning AHU with Variable Speed Drive, CO₂ sensor in wrong location, no record of commissioning, energy wasted

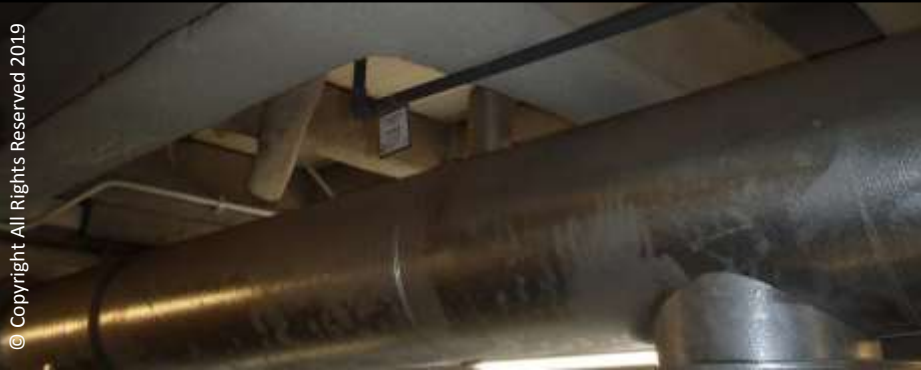
Chilled water pipe header a high level in the plant room traps air (no air vent fitted). Chilled water pumps also found air locked. Air locking restricts water circulation wasting energy.

Chilled water pipe header a high level in the plant room traps air (no air vent) Chilled water pumps also air locked. Air locking restricts water circulation wasting energy.

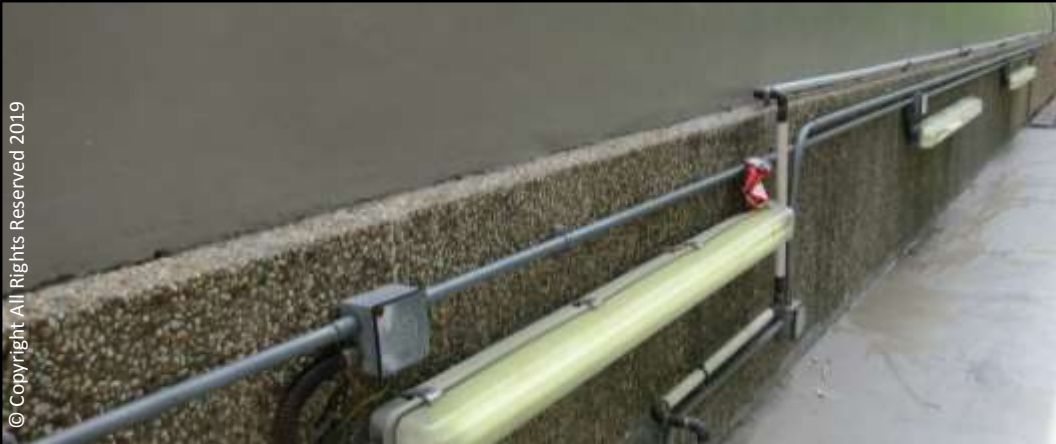
Poorly positioned external lighting, operating 24hrs per day wasting energy.

Poorly positioned external lighting, operating 24hrs per day, wasting energy.

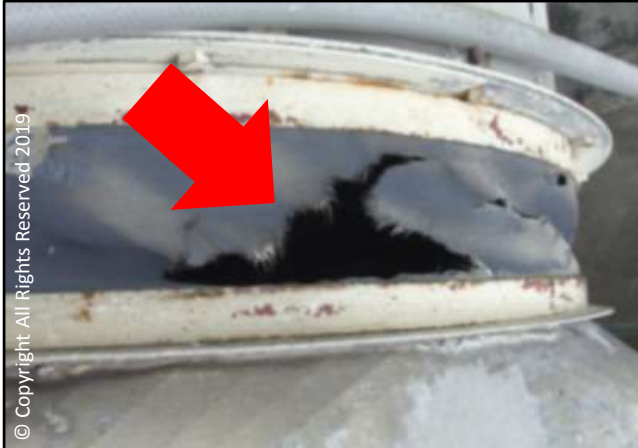
Exhaust fan intake side flexible connection (high pressure location) failed draws outside air, lowering extracted air volume, and wasting energy.

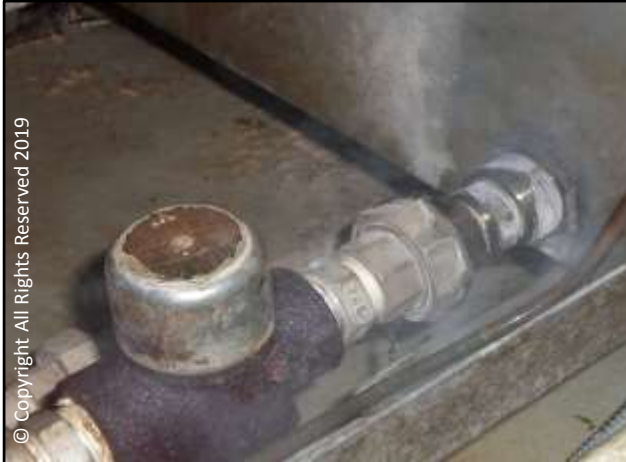
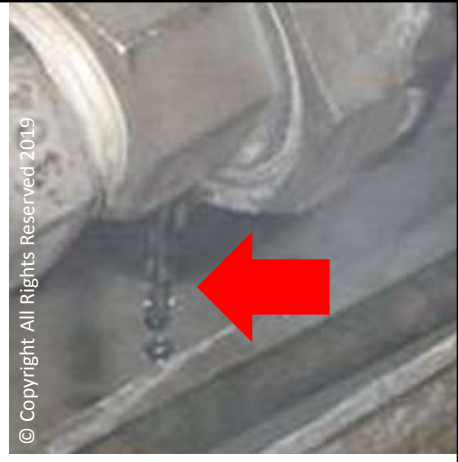
Steam condensate leak flashing to steam, wasting energy and water

Steam condensate trap leak flashing to steam, wasting energy and water

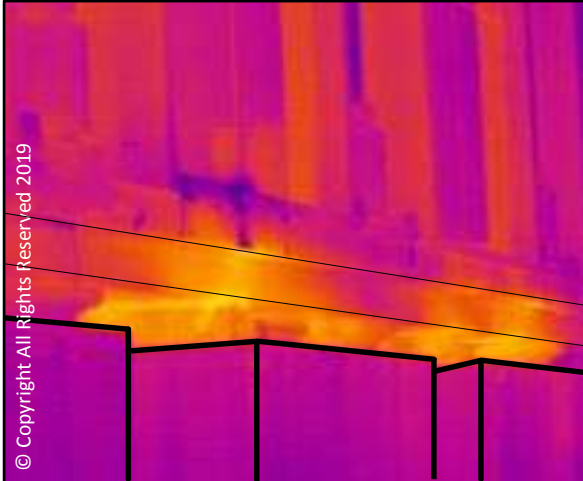
Infra red image, orange colour indicates slab heated to approx. 40 degC, by hot air discharging from air conditioning units below, and heating up the building, wasting energy
