DRAINAGE REPORT

John A Herbert

This report is based on the visual inspection of several sample apartments within the Lung Hang Public Housing Estate, Shatin, Hong Kong. The inspection, arranged and coordinated by the office of Legislative Councillor Emily Lau, was conducted at 2.30 pm on 2nd May 2003. Members from the Housing Authority Lung Estate office led by Mr Chu, representatives from Emily Lau's office, Mr Wilson Chu Esq. District Councillor, Shatin District Council and Mr John A. Herbert, Kelcroft Consulting Engineers attended.

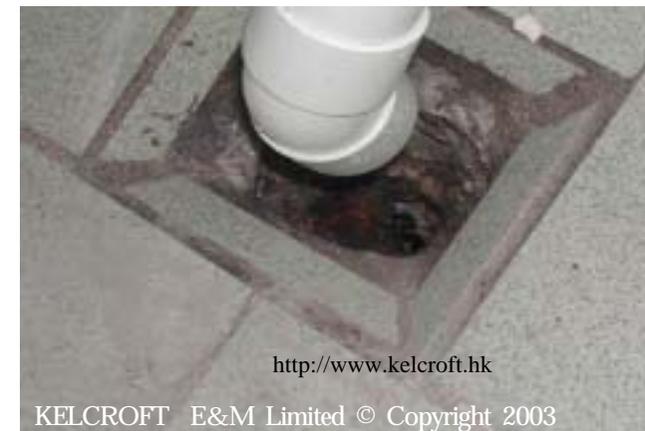
Drainage Installation - Photograph 7

Typical Floor Drain

- Opening formed in concrete slab
- No water proofing visible
- No components visible

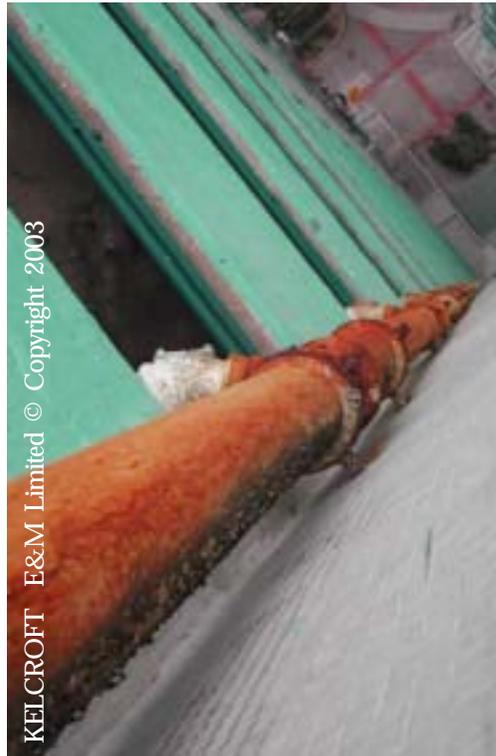
Storm Water
Downpipe

9. Contravention of regulation⁸, clause 36. External 150 mm (6 inch) Cast Iron Storm water pipework fitting Lok Sam House at level 24, has failed (refer photo xxx).

- H block Style building
- 150mm Cast Iron downpipe
- Pipe fitting failed
- Leakage and corrosion and noted
